Cruise Report ZDLM3-10-2019

Finfish SED trials

Fisheries Department
Directorate of Natural Resources
Falkland Islands Government
Stanley, Falkland Islands

7 November 2019

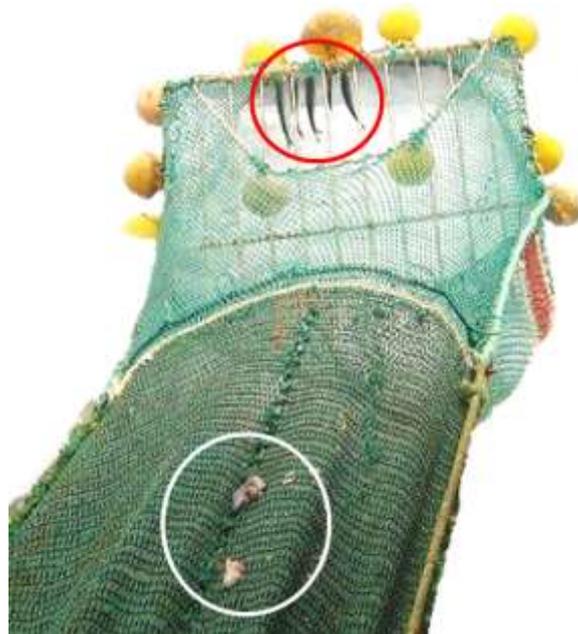
Fig.2. Fish loss through SED in a finfish vessel. The position of the enmeshed fish indicates an upward current flow through the hatch. Note the short SED's next extension; it is unknown whether this SED had either a mesh panel or a high-speed funnel to canalise the water flow through the grid towards the cod-end.

Since the delineation of the SED compulsory area the fishing effort within its boundaries has maintained (Table 1). However, crew from vessels that had worked there mentioned problems related to the use of approved SED models for LOL, particularly grid clogging and the loss of catch through the SED's hatch (Fig.2). In consequence, it was decided to carry out trials of different SED models in search of a device that could both minimize the failures mentioned above and allow the safe escape of seals.

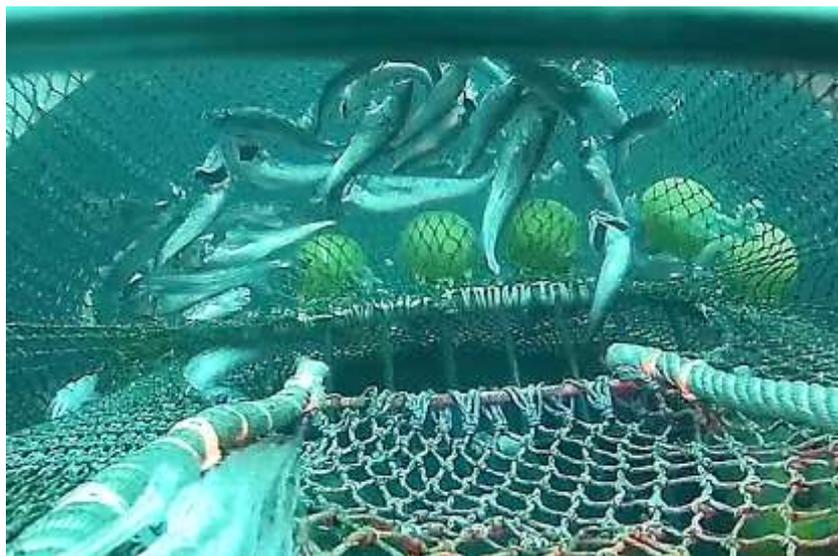
Fig.14. HAK retained in hood.

Throughout the first three evaluation days, the hood model resulted to be the most promising and it was decided to continue the survey fishing with it (Table 3). Although the data analysis is preliminary, the most remarkable characteristic of the SED hood model is its capacity to retain escaping fish during trawling (Fig.14), however some fish may escape in the early stages of the haul, when the vessel diminishes its speed and tension of the fishing gear is reduced. Fish escapement during trawling was observed for both the visor and streamer models; however the former did not work appropriately (Table 3, Fig.7, 8). No difference was recorded in HAK length, whether fished with or without any SED model (Table 3). Along the cruise it was noticed the importance of the internal design of the SED, as the net panel configuration successfully proved for targeting LOL had to be modified (Fig.3). This is mostly related to the different swimming behaviour of these species, as finfish (i.e. HAK, KIN) have the capacity to swim against the water current and escape.
